# Ld 150, Mks. I, II, III, and Ld 125

## Maintenance

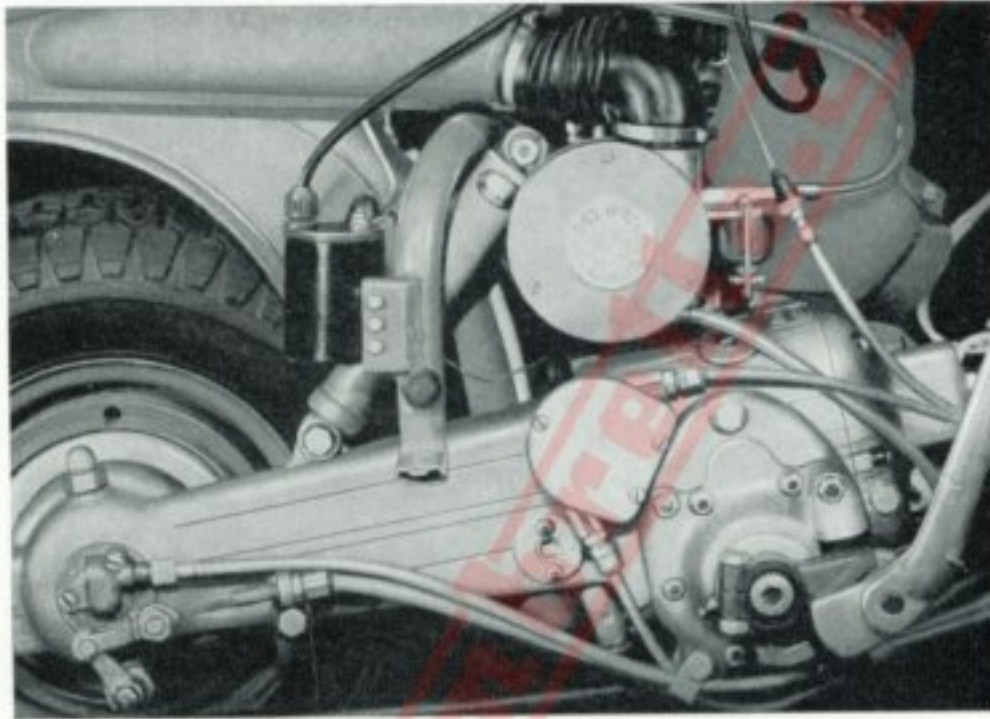
Engine unit of the Mk. III 150 Ld

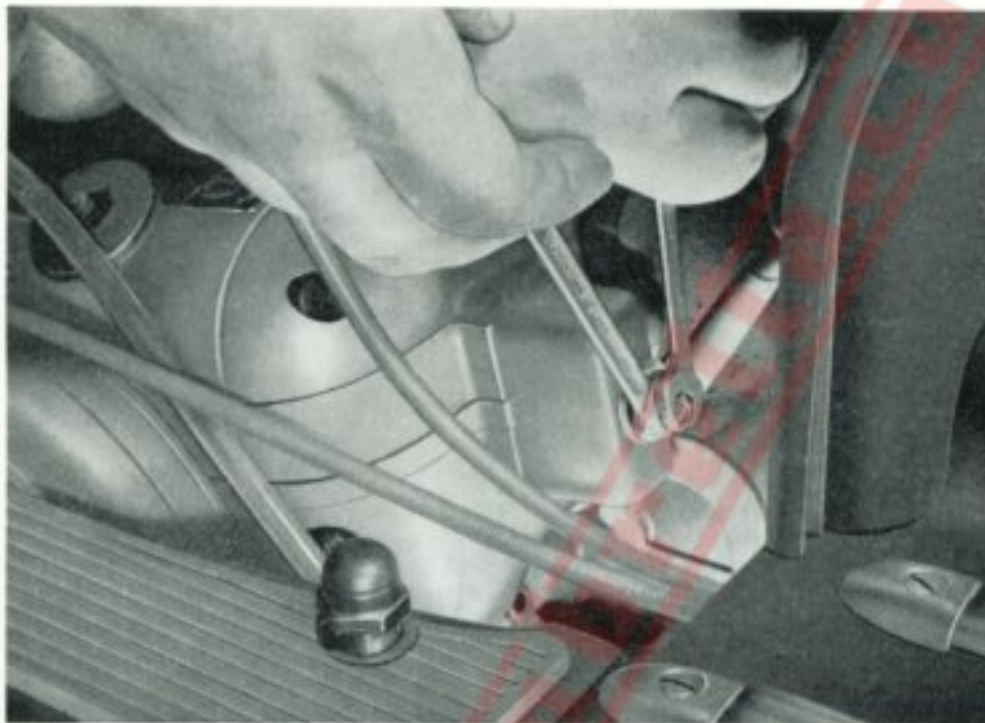
Adjusting the 8 mm. nuts on the clutch pull-rod

The clutch is also adjusted by a knurled screw at the handlebar but there should be at least  $\frac{3}{4}$ " free movement at the tip of the lever. When no further adjustment remains at the lever end, remove the 19 mm. domed nut from the centre of the clutch cover on the offside at the front of the engine compartment and slacken the two 8 mm. hexagon nuts locked together on the end of the clutch withdrawal pull rod beneath, using suitably thin spanners. Set the nuts in a position which will allow the adjustment at the handlebar end to be restored and re-tightened. (Do not overtighten or clutch slip will be experienced).

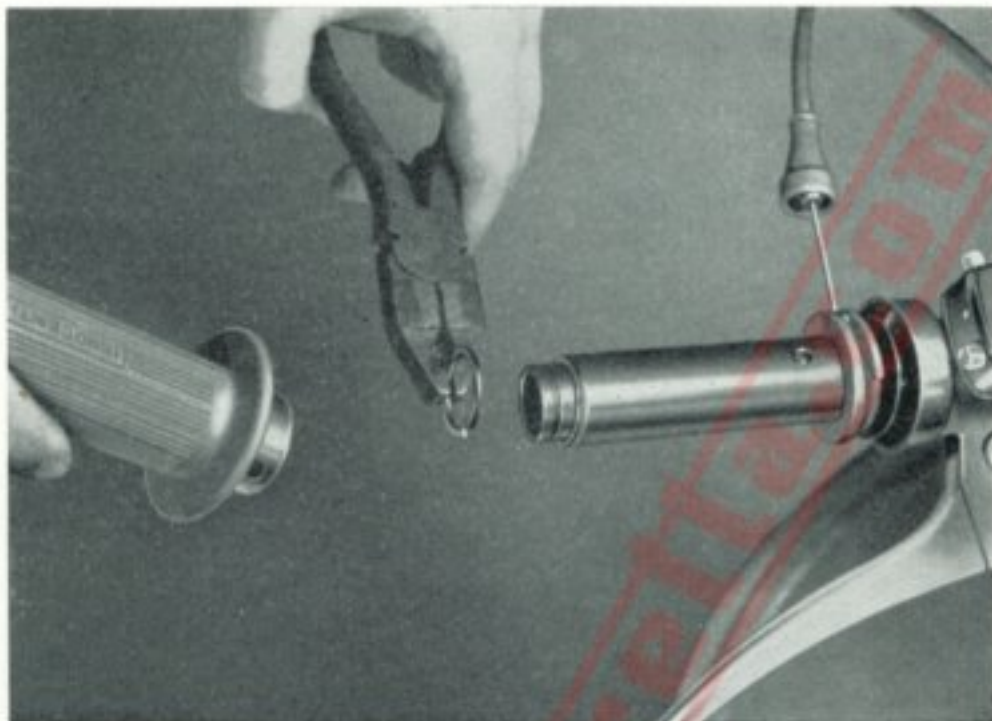
Dismantling the twist grip assembly

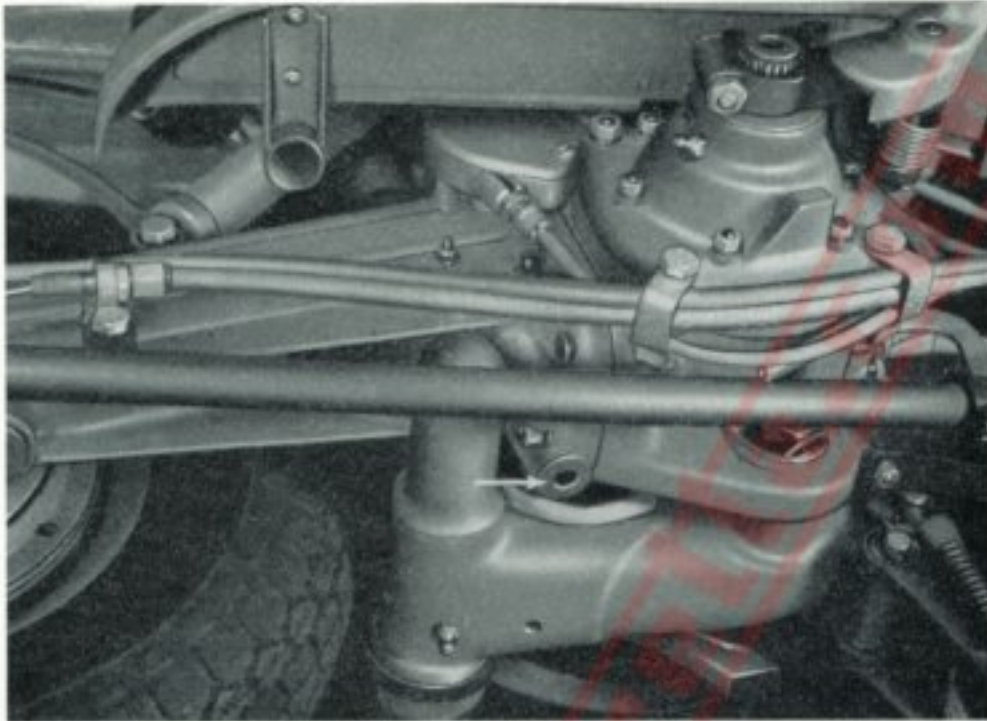
Arrow shows gearbox oil drain plug

When changing the gearbox oil, the correct plug to remove is the one situated beneath the engine immediately ahead of the lug on the frame which contains the torsion bar; the adjacent plug fitted by a 19 mm. spanner contains the spring loading the gear engagement pawl and this must not be removed.

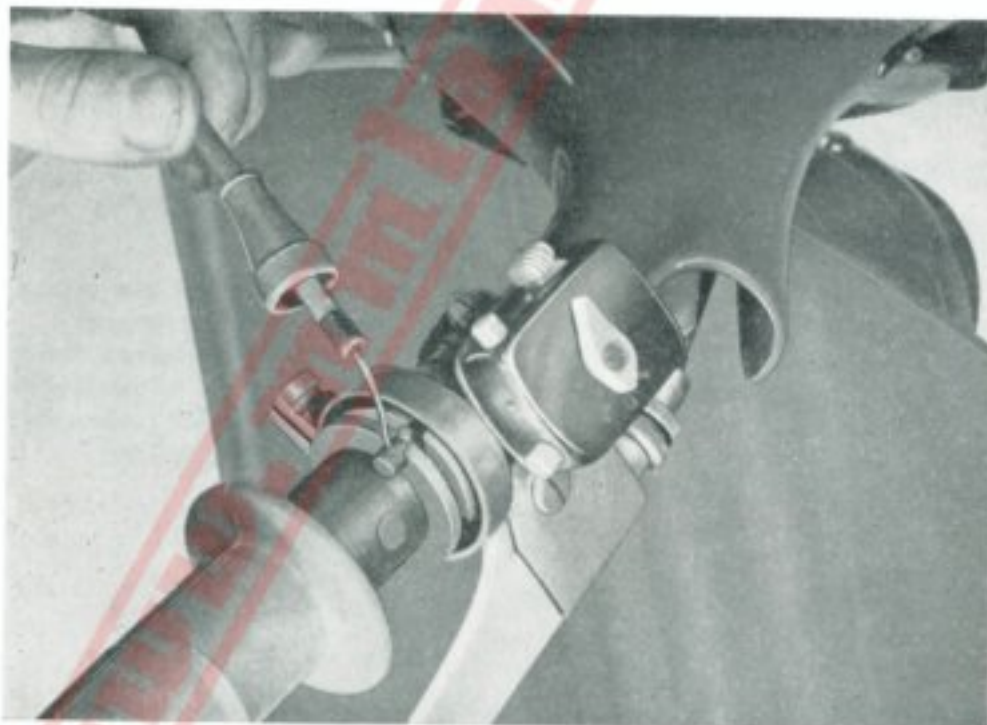
Move the support along the handlebar and slip out the throttle cable

Gear cables or throttle cables should be detached from the end further from the handlebars and by slackening the 10 mm. pinchbolt holding the aluminium support adjacent to the twistgrip, the support may be loosened and slid along the handlebar to allow access to the cable so that the inner may be withdrawn and the new one entered. Where the soldered type of nipple is fitted to the gear change remove the offside pillion footboard. Take off the selector box cover, the selector box and arm from the casing before attempting to slip out the cable nipple from the selector arm. The box is held by three screws which can be reached with a large screwdriver if first gear is selected. Since the screws will be very tight they should each be loosened by a blow from a hammer and drift placed on the screw head. A circlip surrounds the selector shaft and must be lifted off before the assembly can be withdrawn by levering with a screwdriver behind the box. Note the position of the selector arm on the splines for refitting.

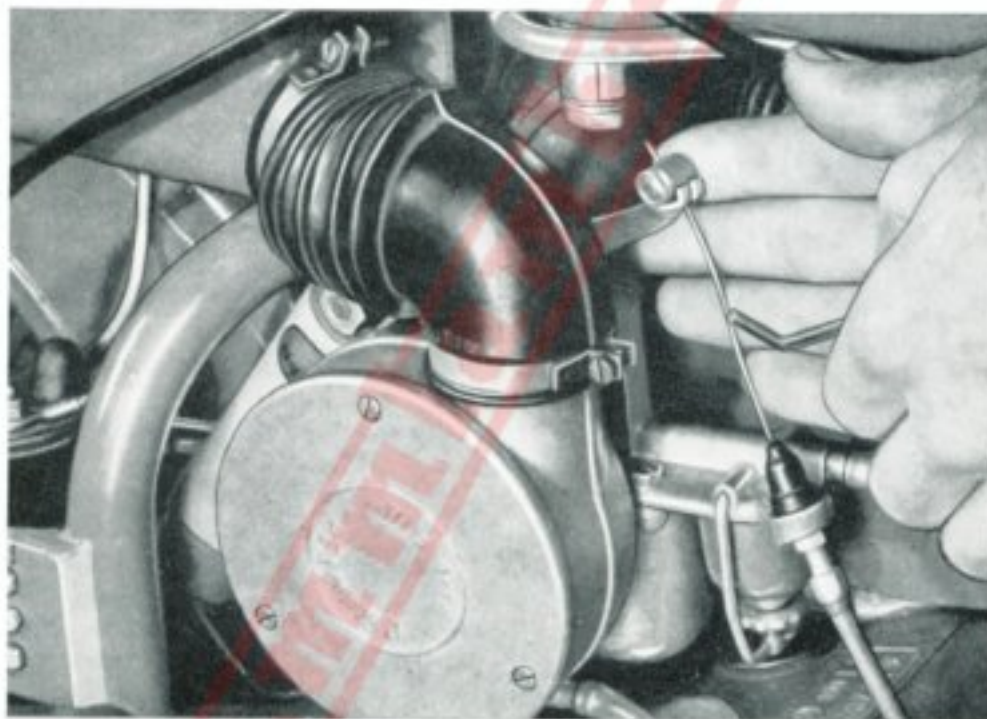
Using the detachable nipple 1 5022030 to secure a throttle inner cable

Besides the tools in the kit, which includes the  $3\frac{1}{2}$  mm. allen key 15086066, a medium sized pair of pliers are necessary. With these, the detachable nipple can be held while the  $3\frac{1}{2}$  mm. allen grub screw is slackened or tightened, and also, in the case of the gear change, the inner cables can be pulled taut.

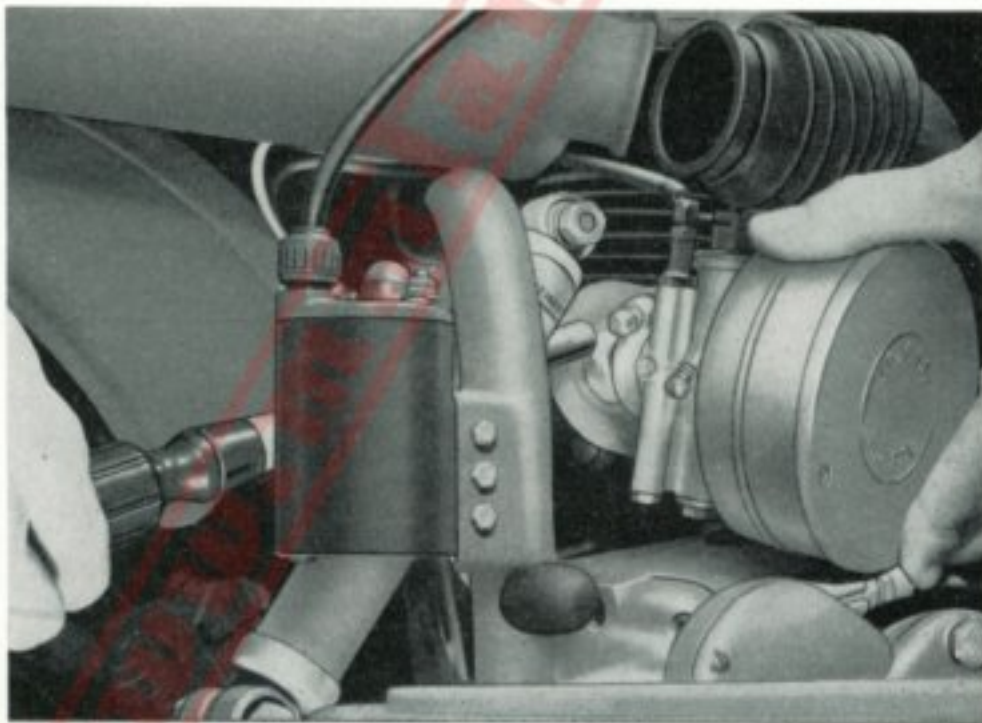
Slackening the 8 mm. pinchbolt with socket spanner 1010 to release the carburettor

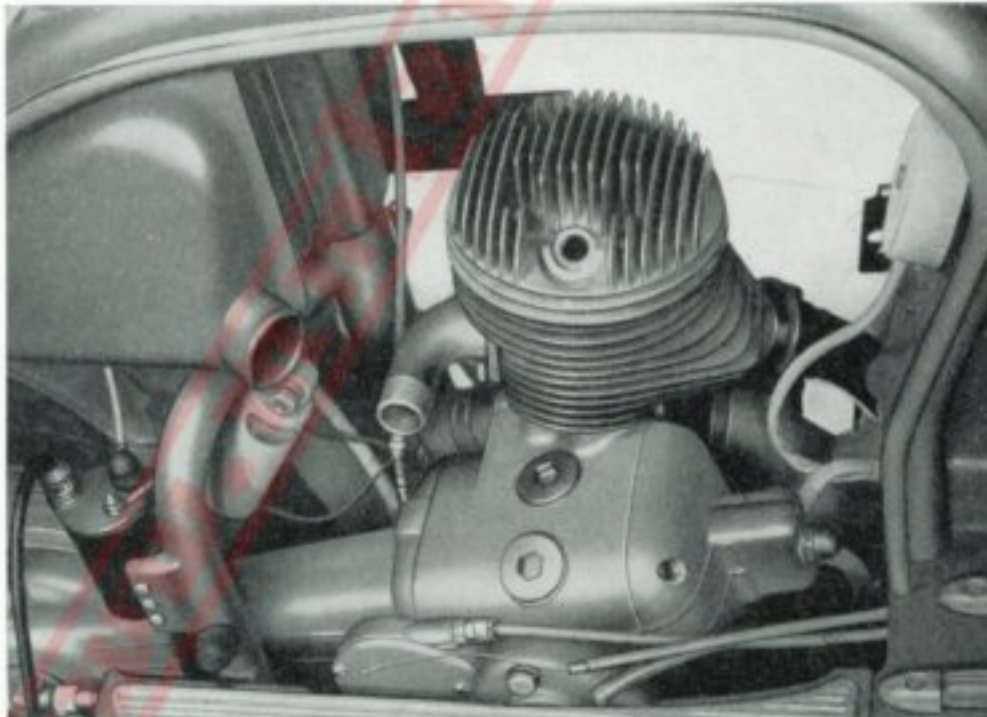
The cylinder exposed for dismantling and decarbonisation

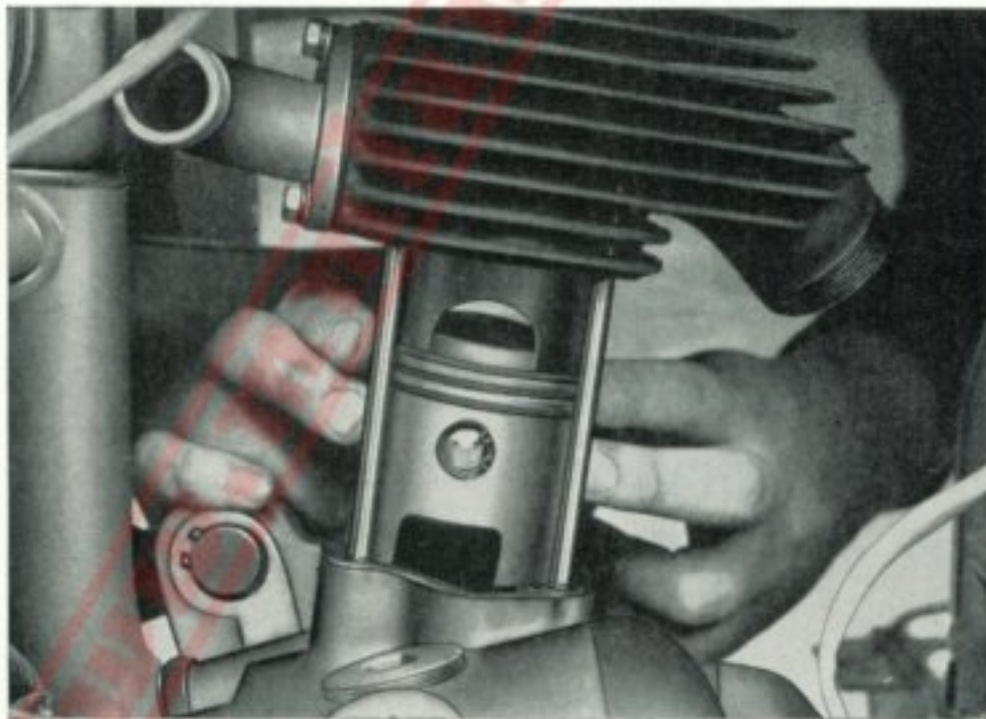
Allow the cylinder to slide on by its own weight while positioning the rings

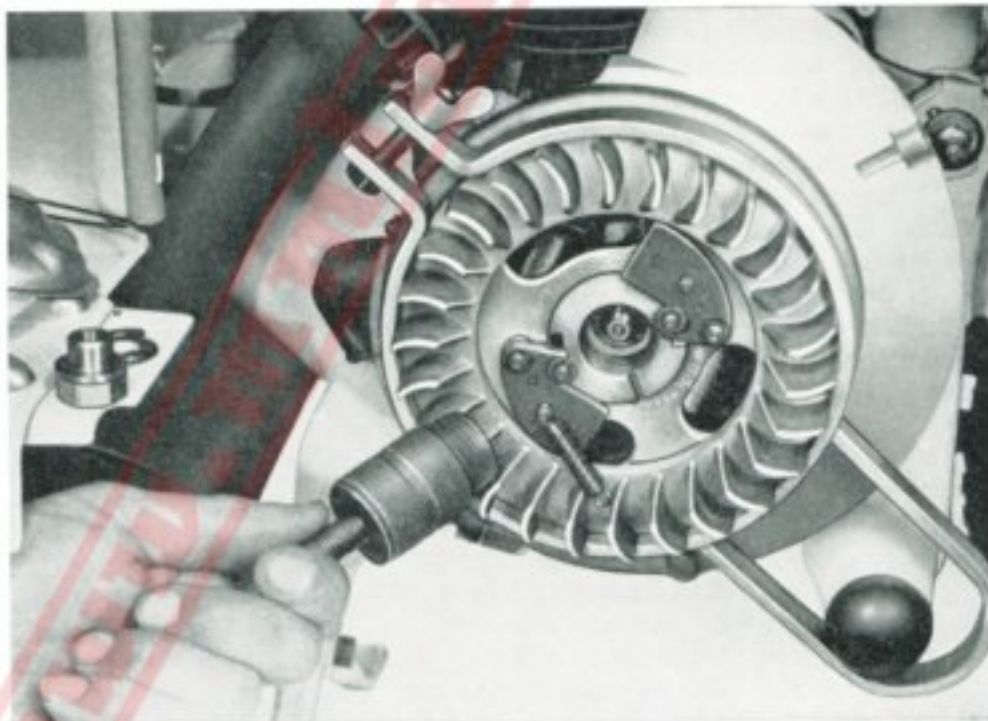
Holding the flywheel with tool 49220/E while applying the extractor 37058 2E

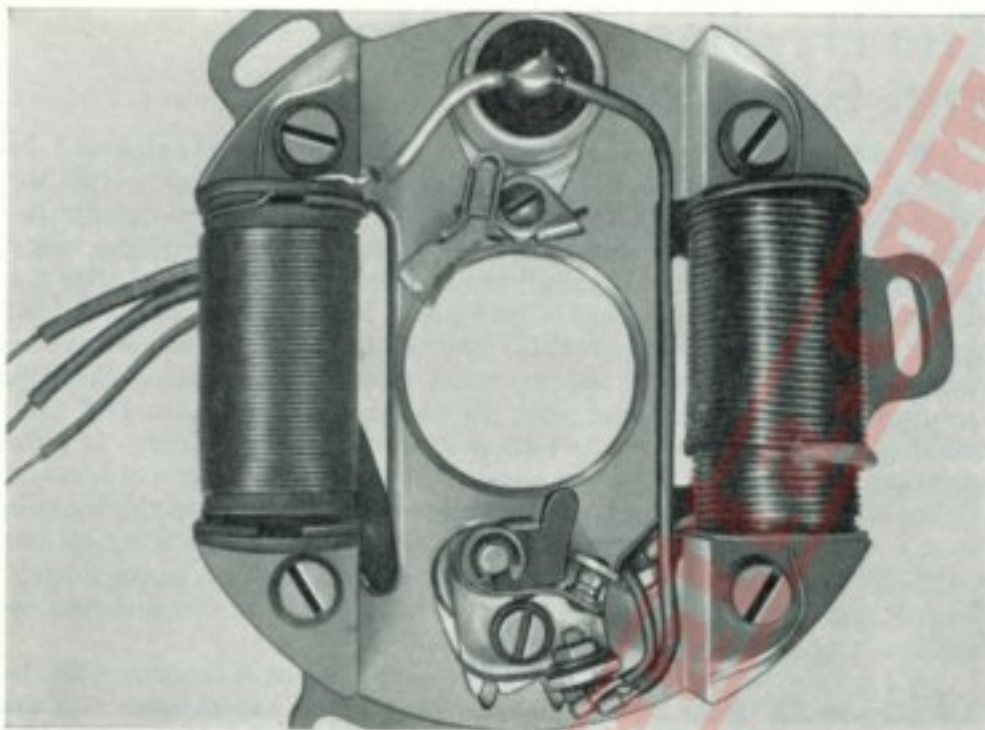
Stator plate of the Filso magneto

The setting of the stator plate, which is adjustable by three screws in slotted holes fixing it to the inner flange member, is arranged so that the in-between pole position occurs 10 degrees before the timing marks which are in turn 26 degrees before top dead centre of the piston. This total

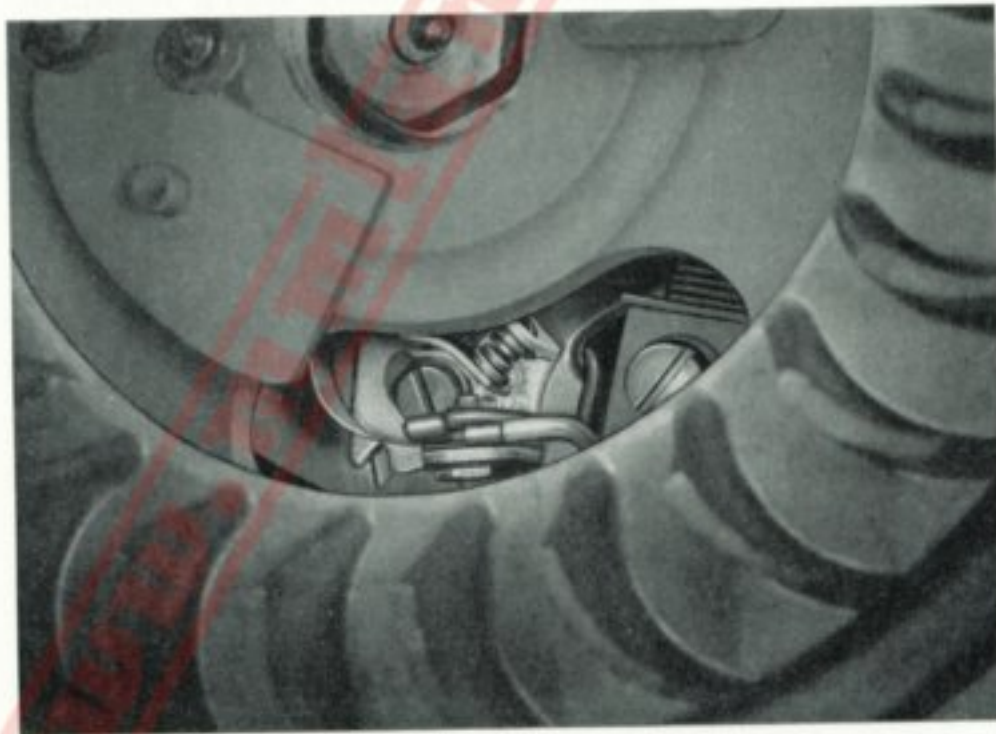
Filso contact points, Note locking screw and V-notch adjustment

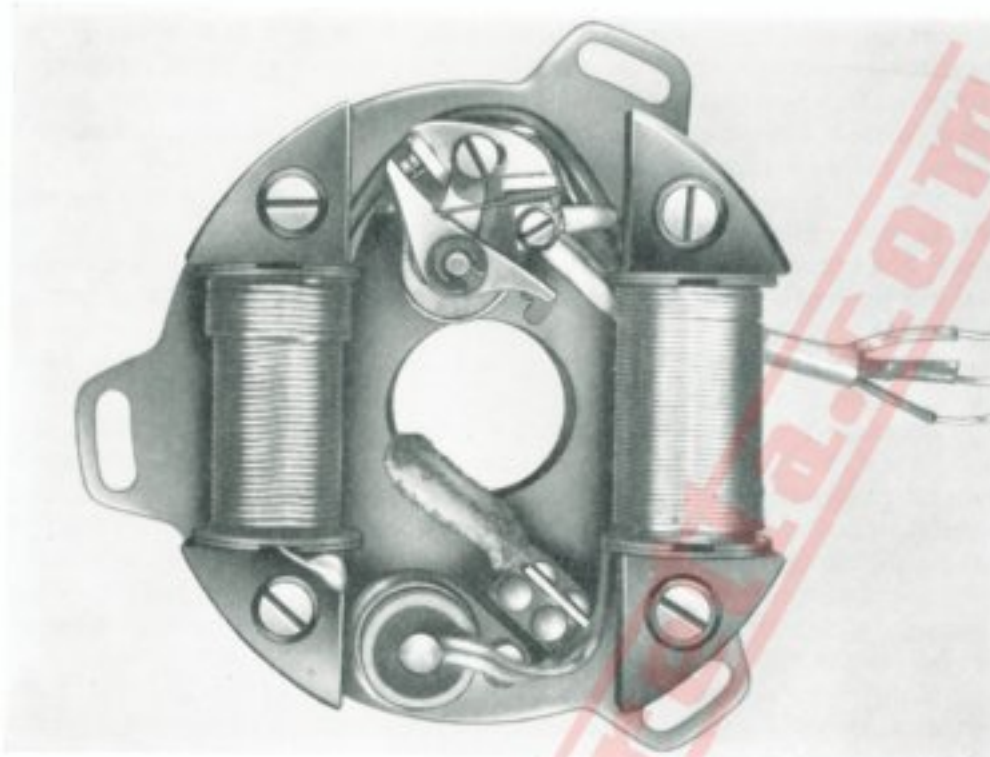
Stator plate of the Marelli magneto

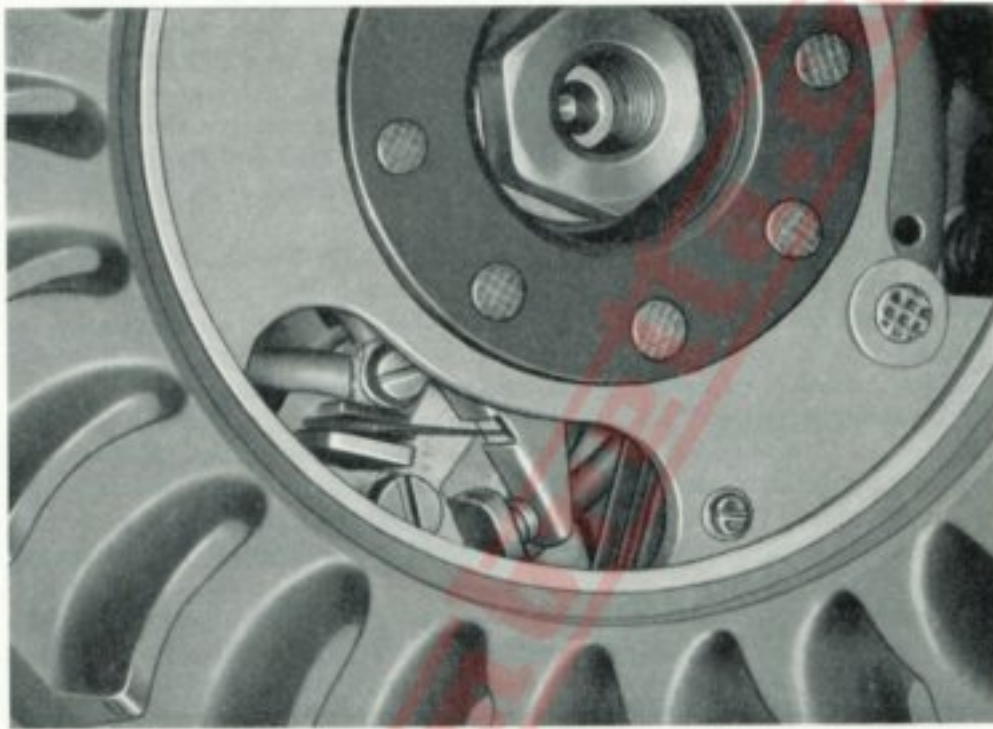
Marelli contact points

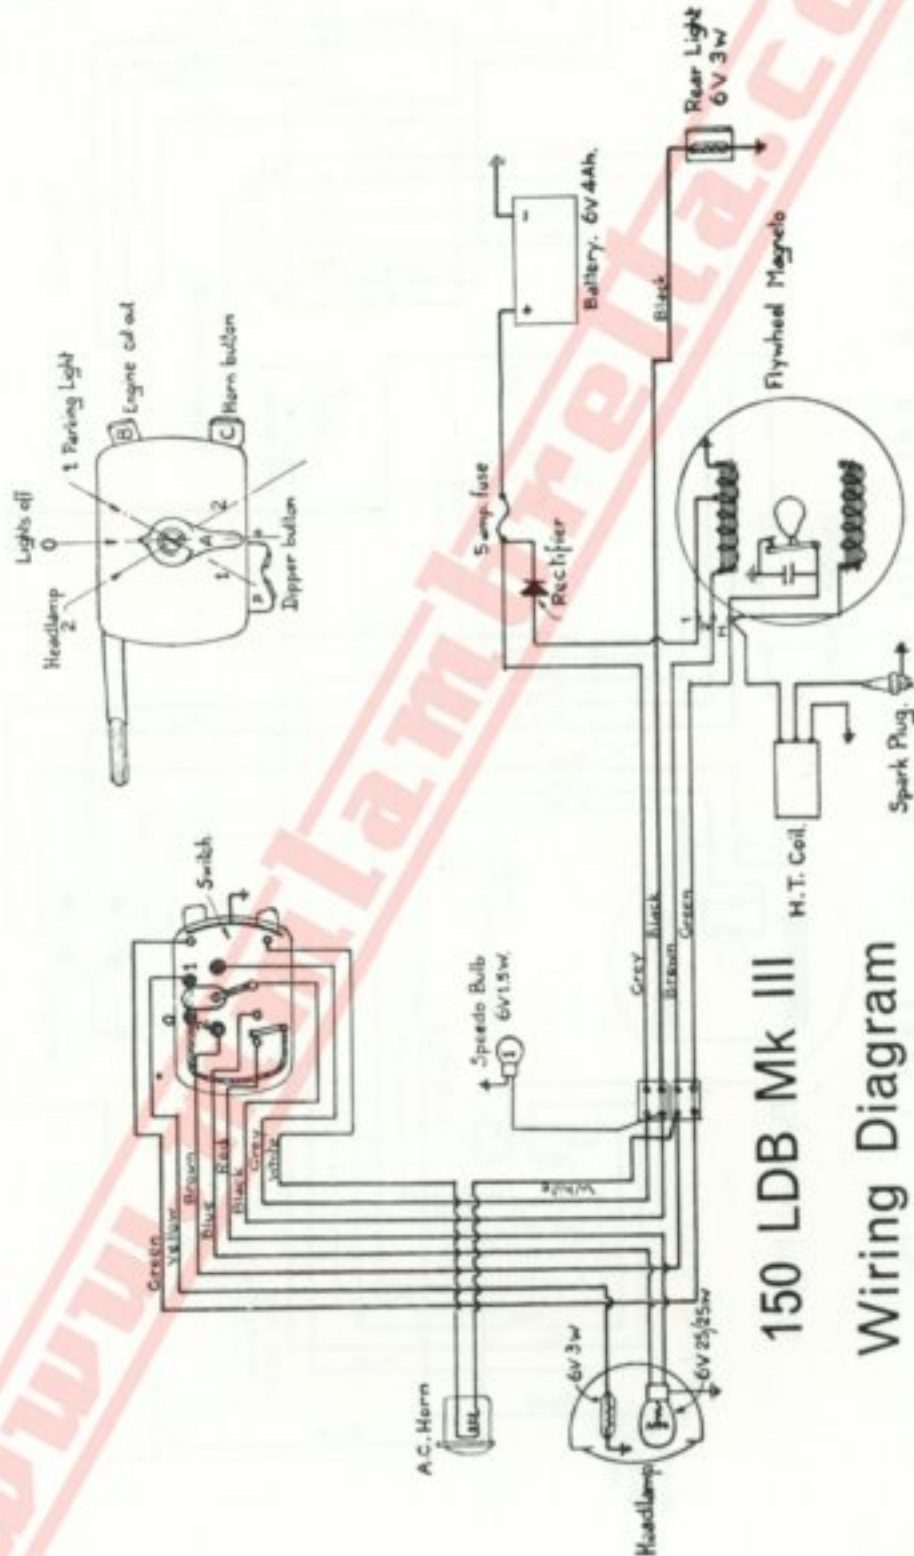
150 LDB Mk III  
Wiring Diagram

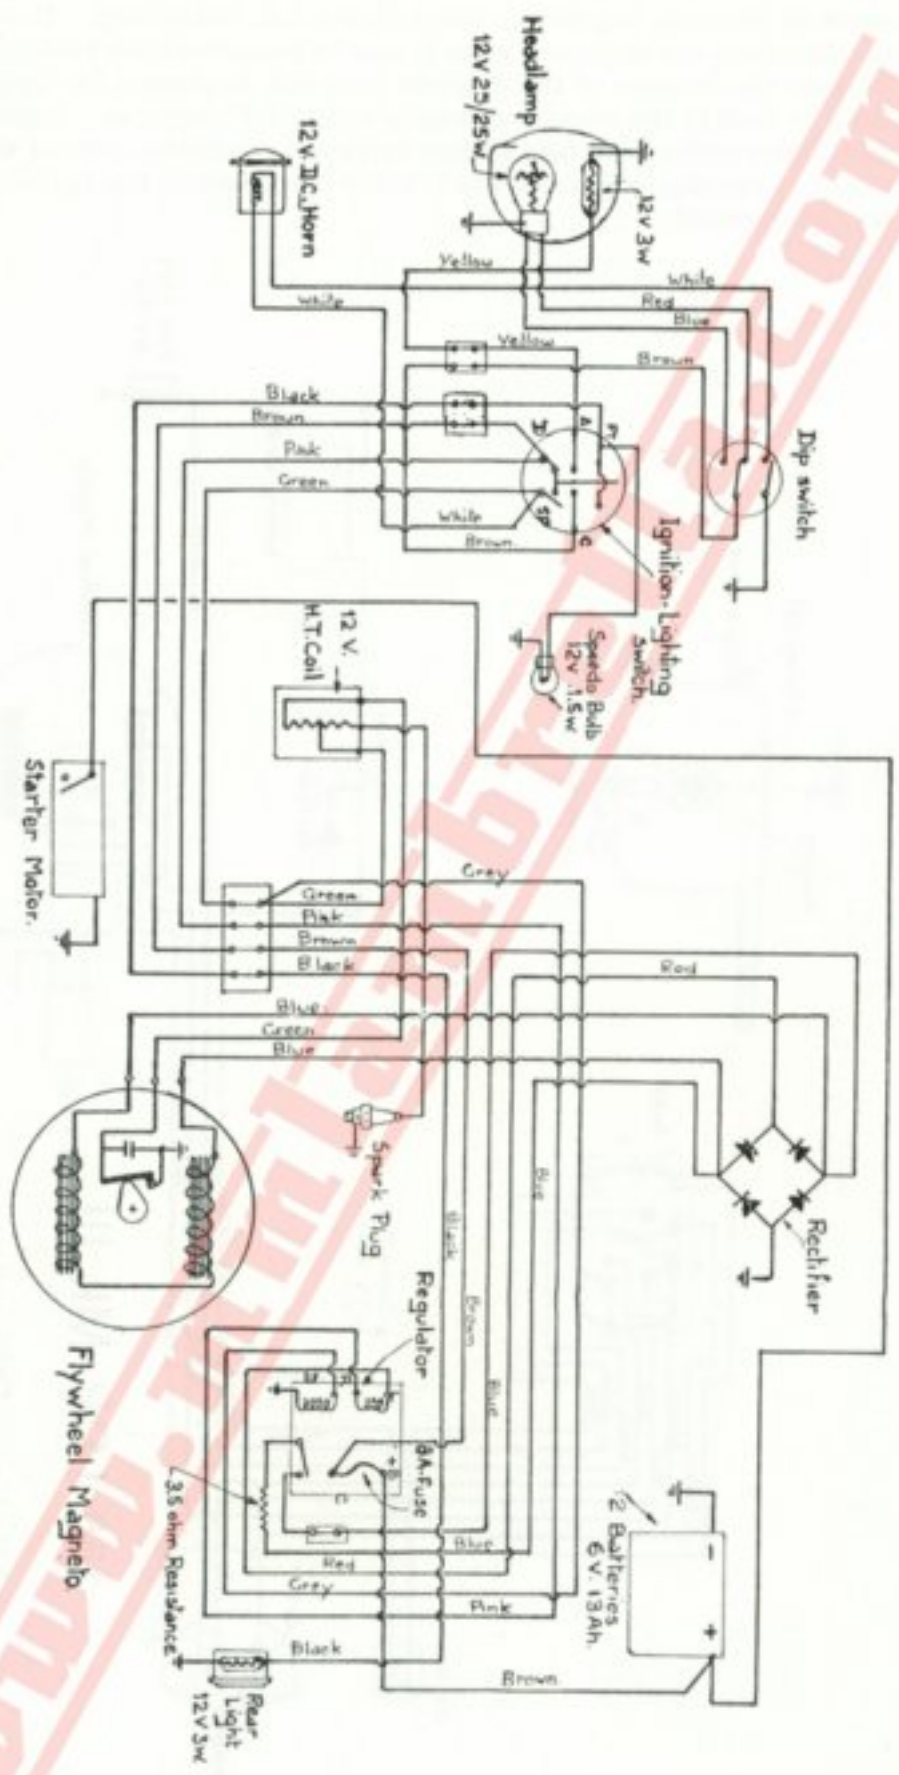
Lambretta 150 LDA MK I-III Self Starter Wiring Diagram
